PHOTOGRAPHIC LOG

Client Name:
Village of Whiting

Site Location:
McDill Dam

Project No.:
60513928

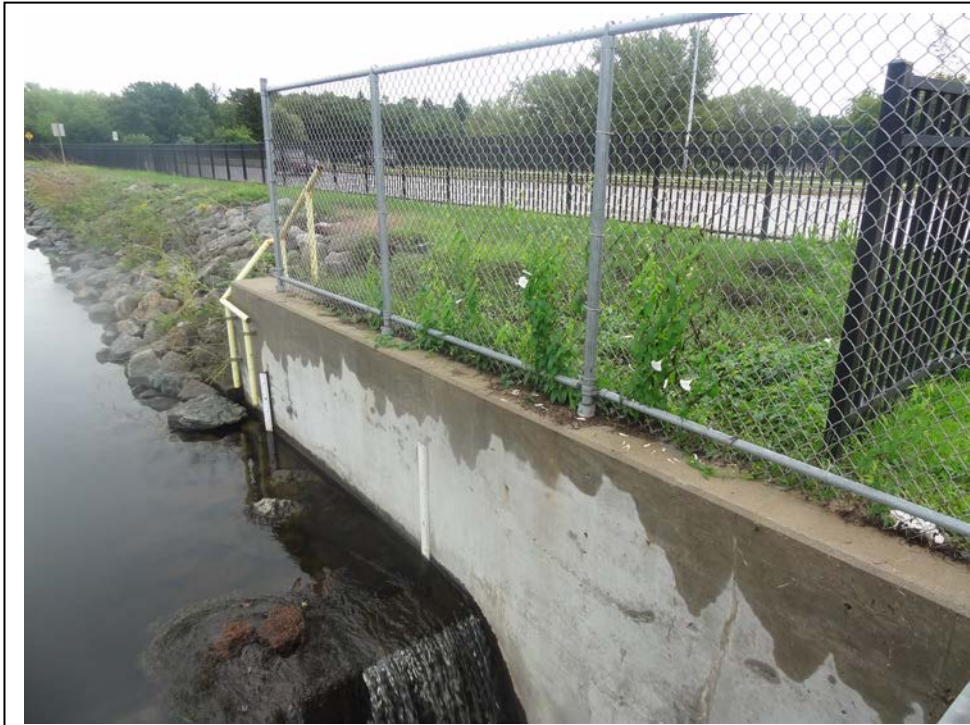
Photo No.
1

0017608241602384
U/S Headwall

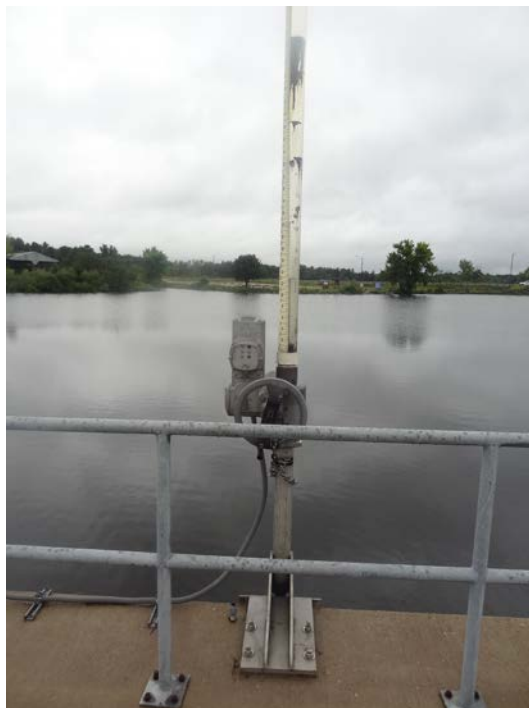
Photo No.
2

0017608241602386
East Gate Hoist and Indicator

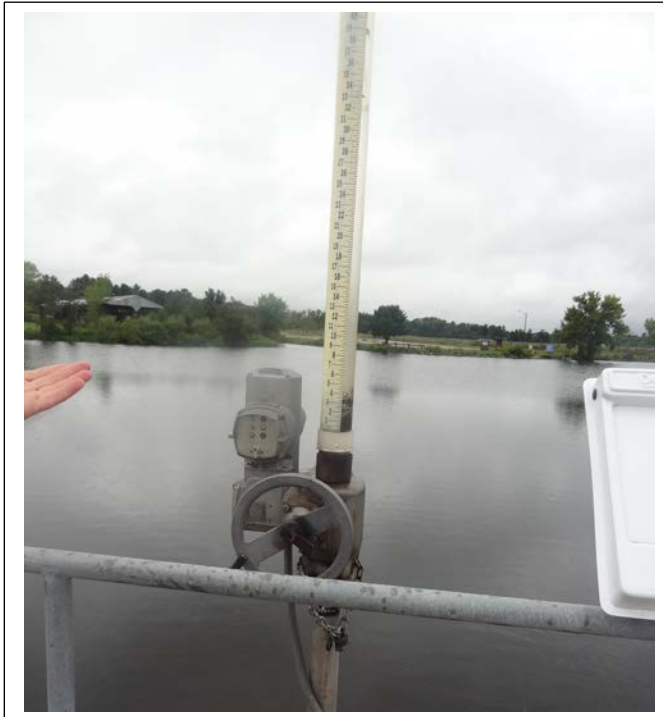
Photo No.
3

0017608241602387
West Gate Hoist and Indicator

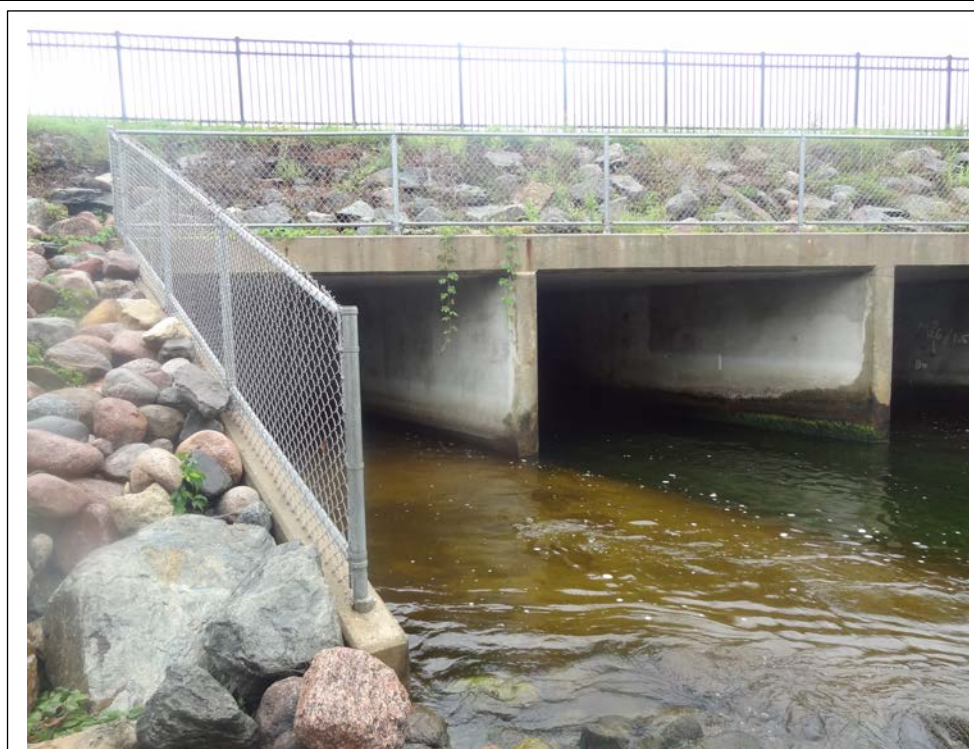
Photo No.
4

0017608241602388
Box Culvert D/S Outlet
looking NE

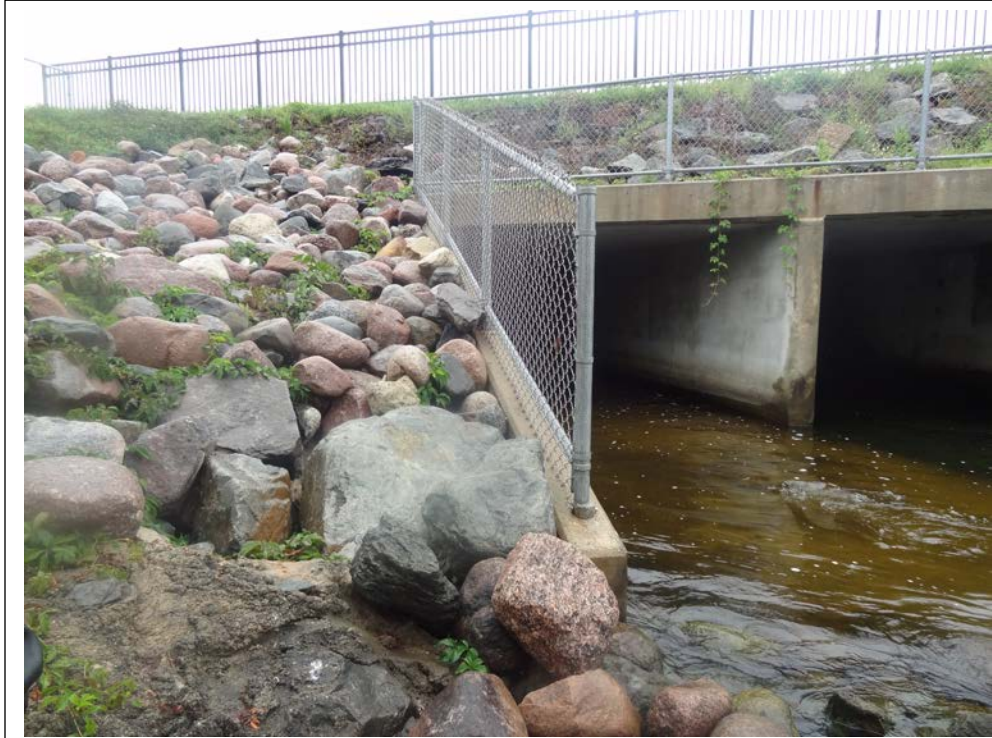
Photo No.
5

0017608241602390
Box Culvert D/S Outlet
looking NE

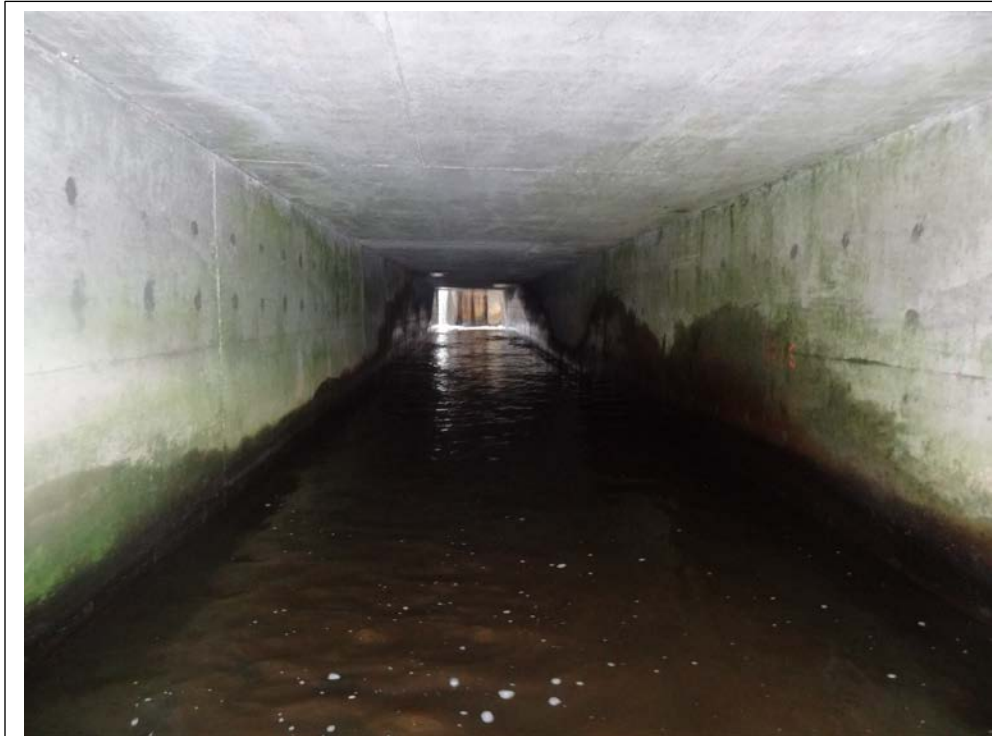
Photo No.
6

0017608241602393
Middle Box Culvert
looking U/S

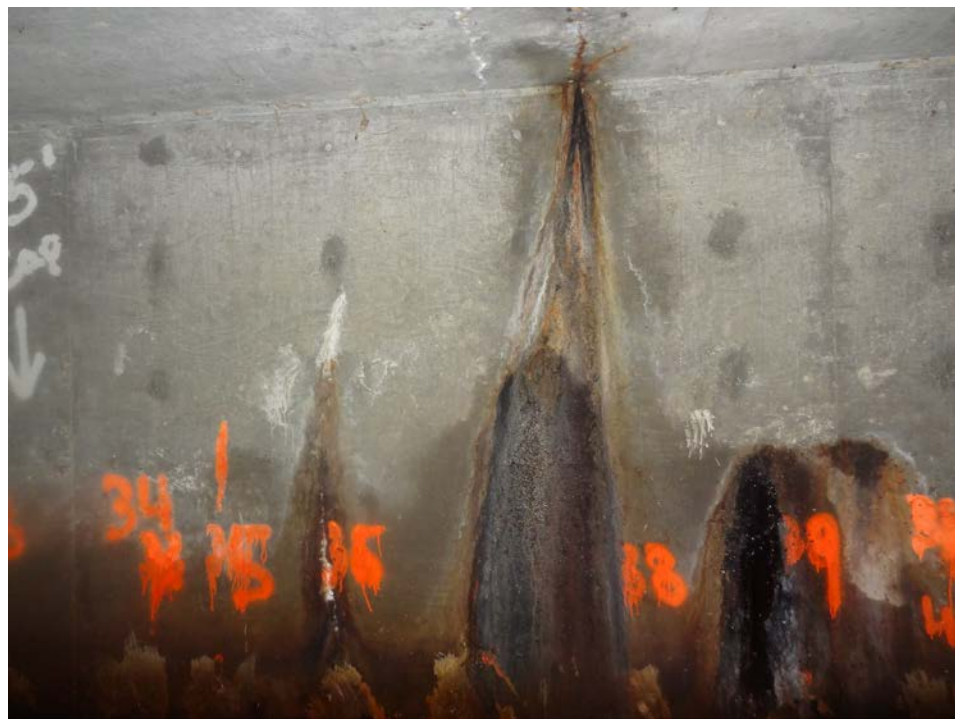
Photo No.
7

0017608241602398
East Box Culvert

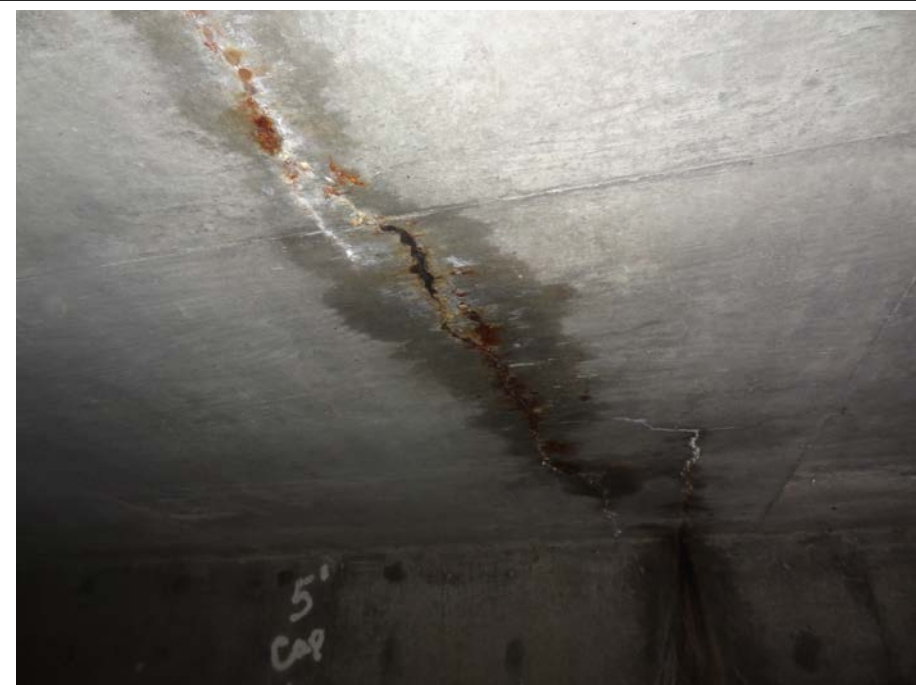
Photo No.
8

0017608241602399
East Box Culvert

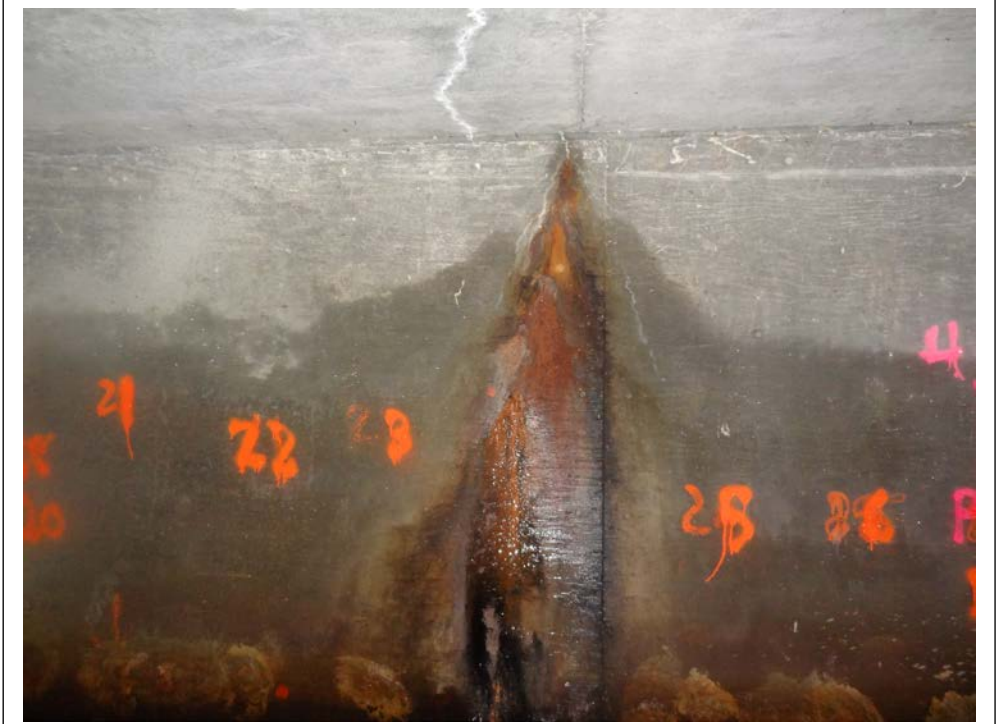
Photo No. 9	Date: 8/24/2016
-----------------------	---------------------------

0017608241602400
East Box Culvert

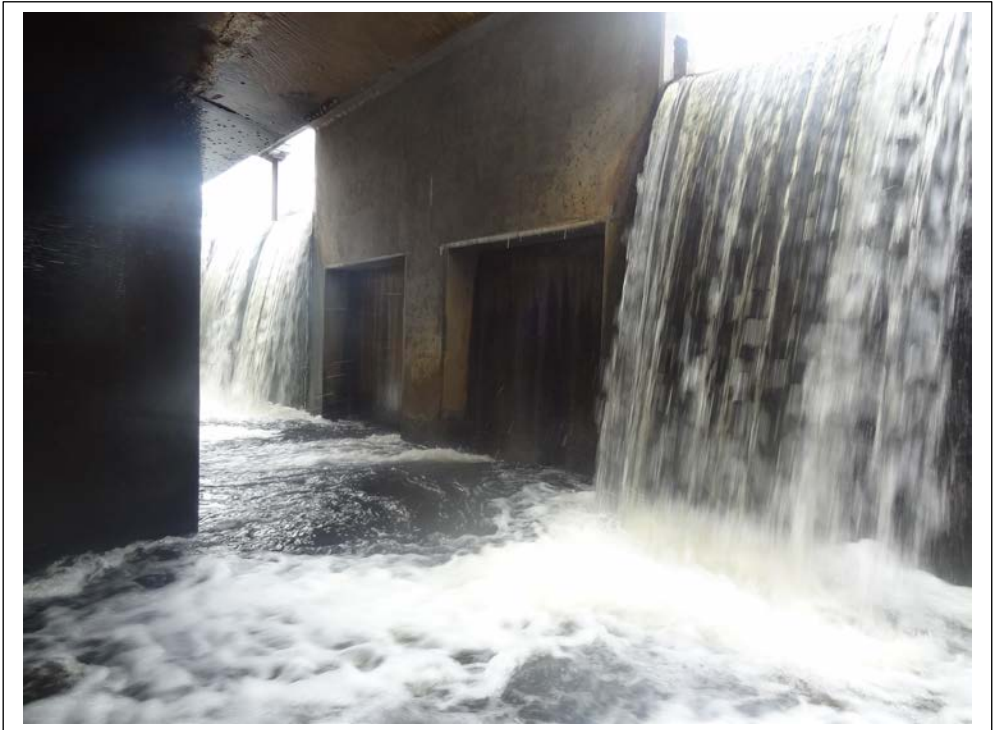
Photo No. 10	Date: 8/24/2016
------------------------	---------------------------

0017608241602401
U/S End East Box
Culvert looking NW

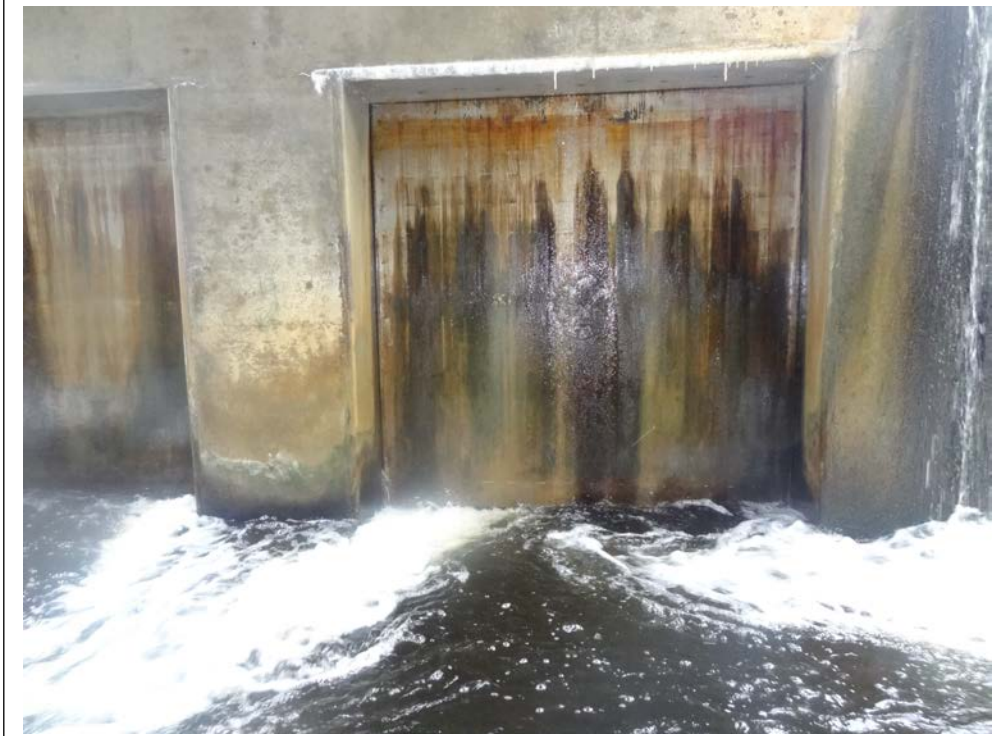
Photo No.
11

0017608241602404
D/S Side of East Slide Gate

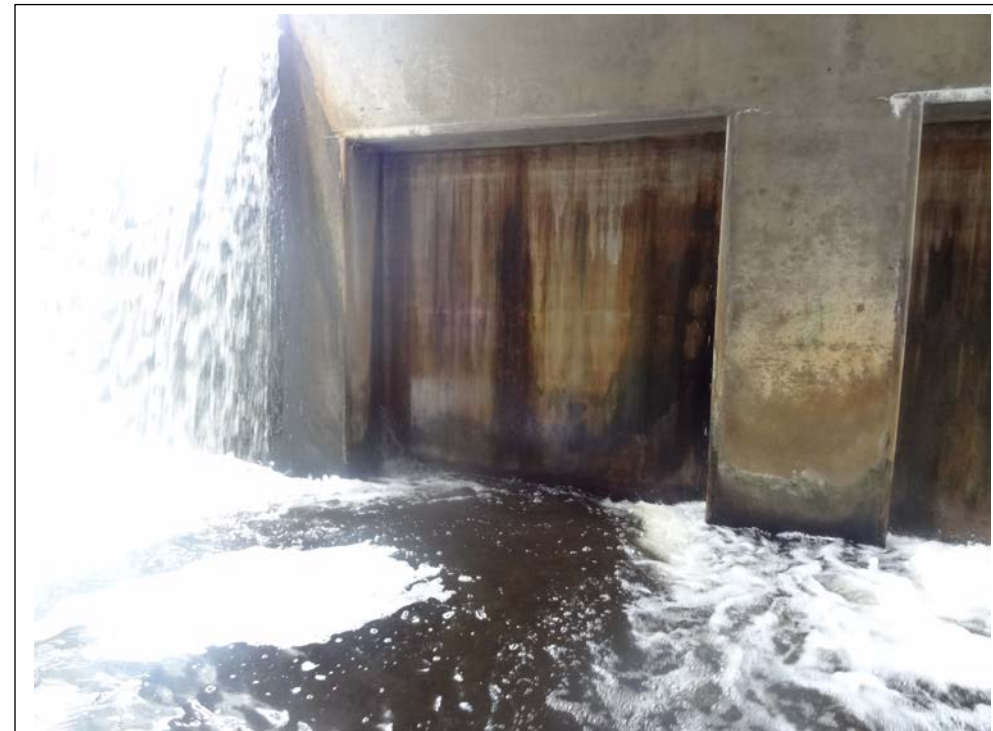
Photo No.
12

0017608241602405
D/S Side of West Slide Gate

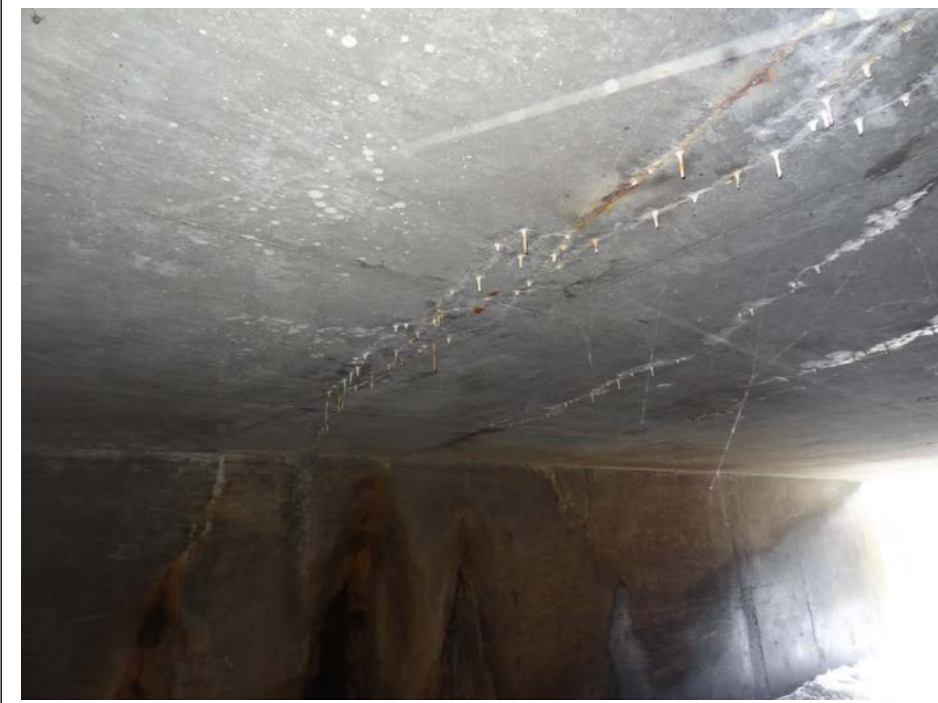
Photo No.
13

0017608241602408
West Box Culvert

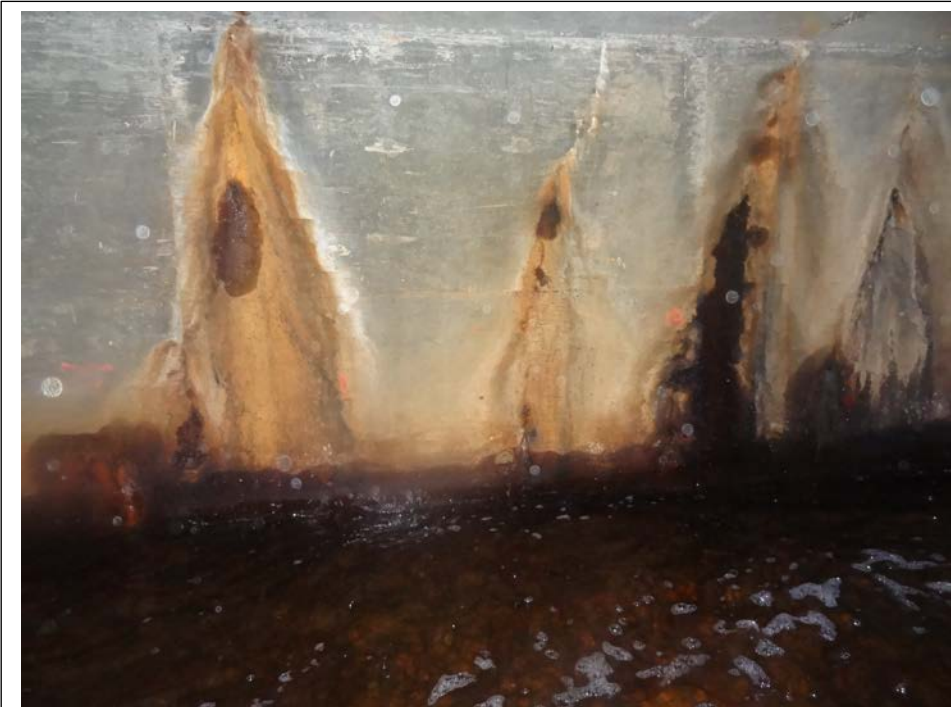
Photo No.
14

0017608241602409
West Box Culvert

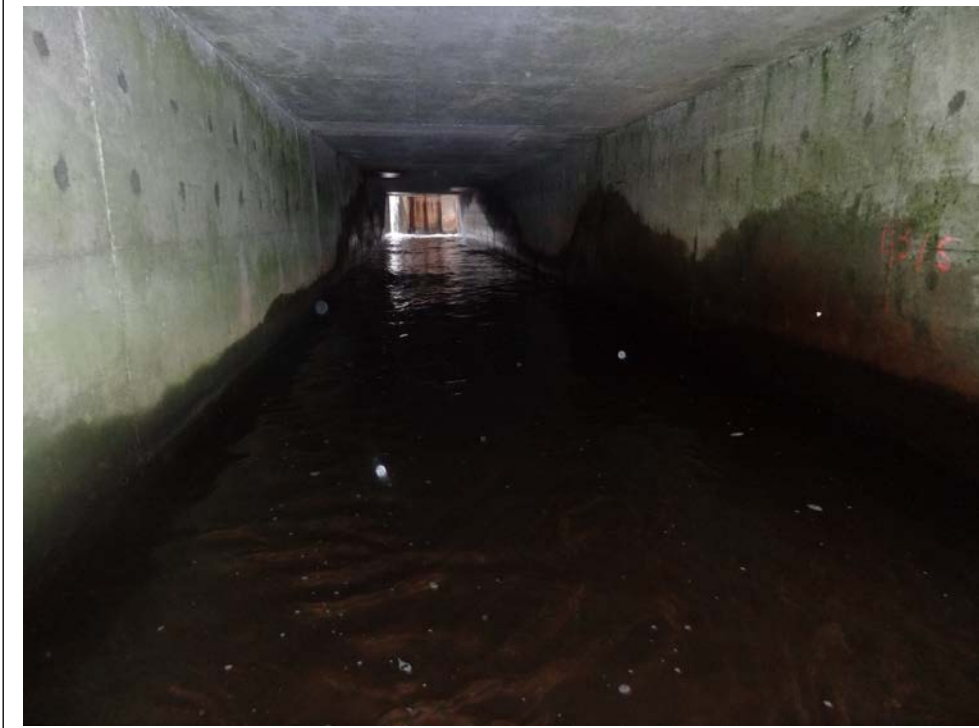
Photo No.
15

0017608241602410
Middle Box Culvert
looking U/S

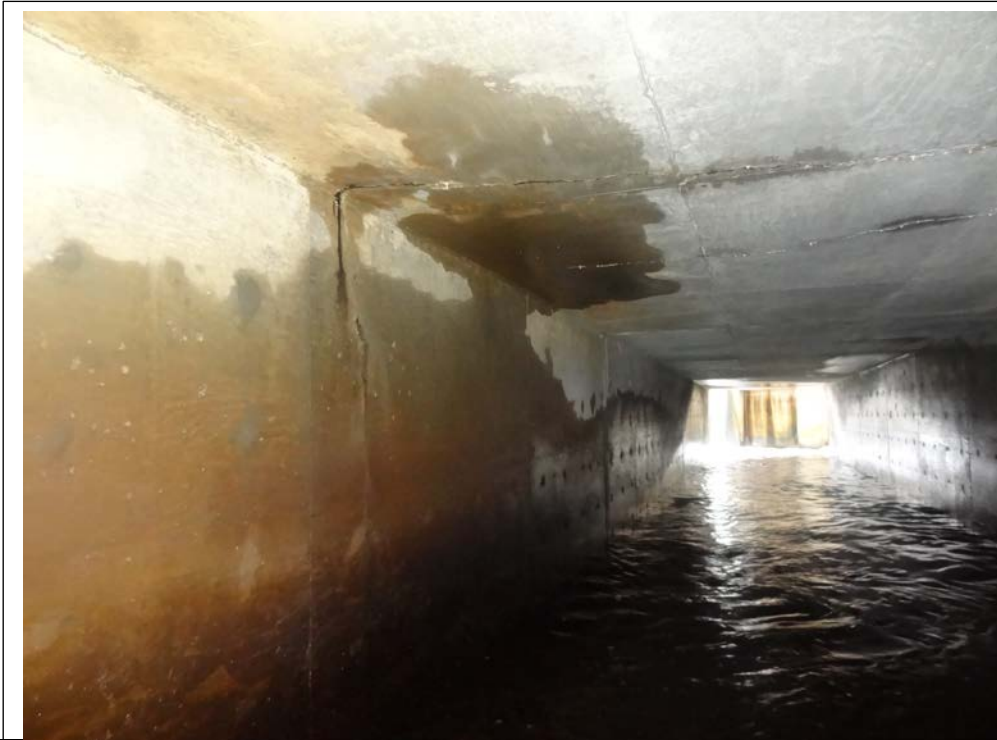
Photo No.
16

0017608241602412
Middle Box Culvert
looking U/S

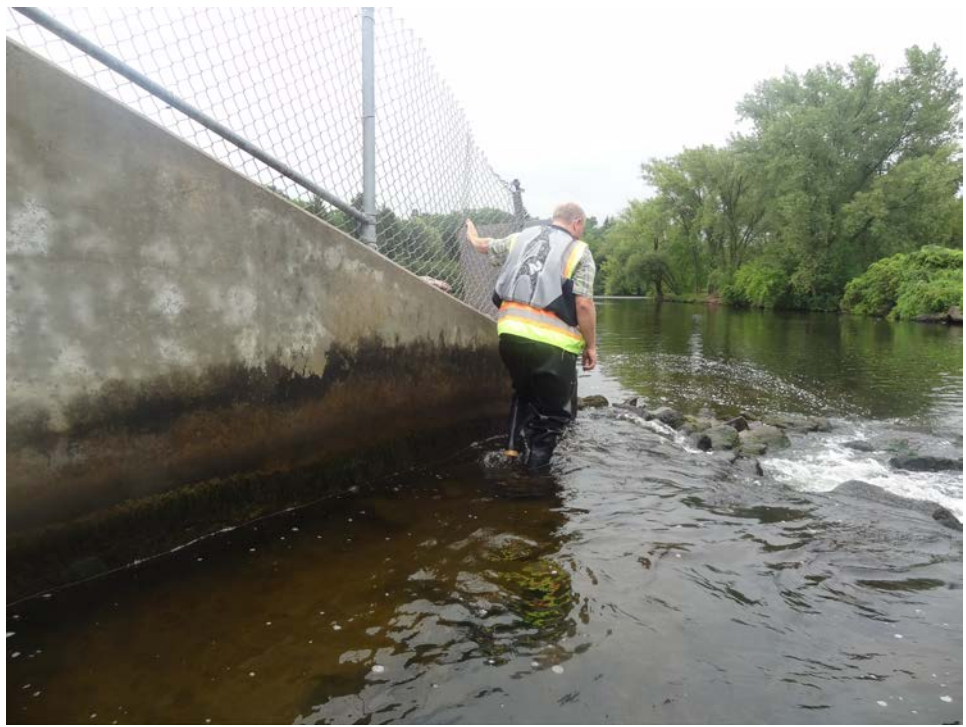
Photo No.
17

0017608241602415
D/S Apron East
Wingwall looking SE

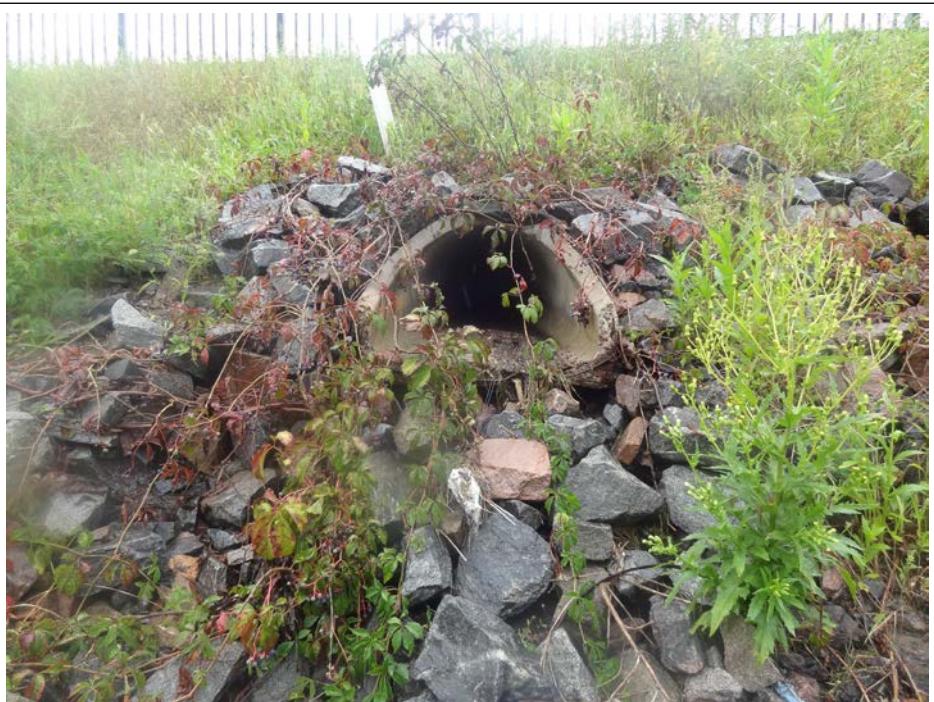
Photo No.
18

0017608241602420
Storm Outfall D/S
Embankment

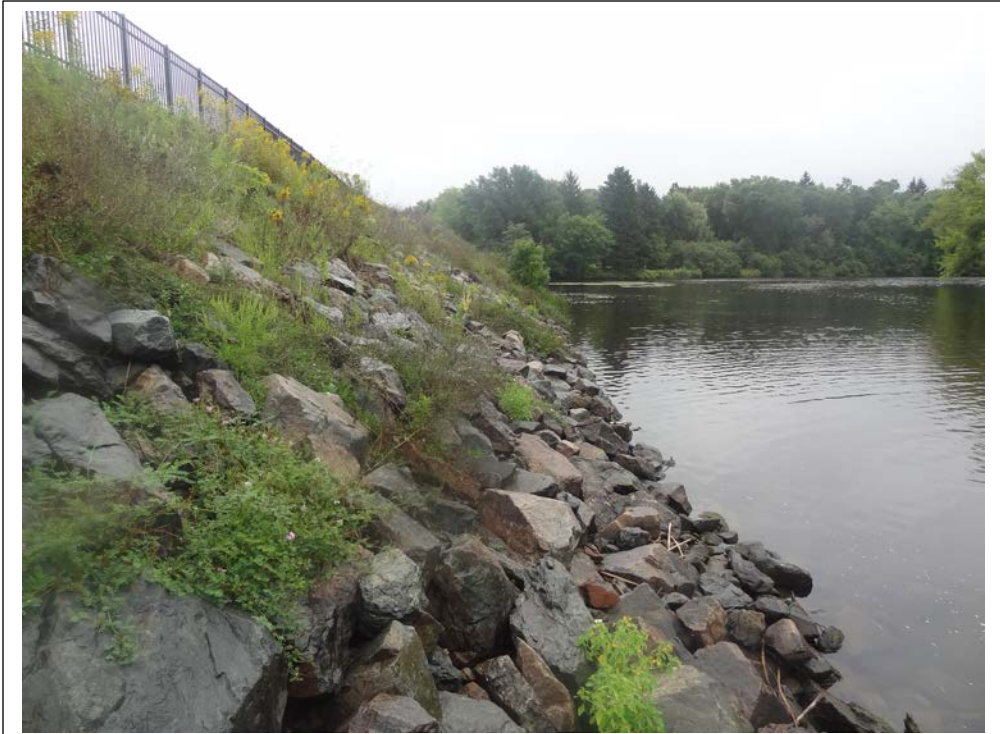
Photo No. 19	Date: 8/24/2016
------------------------	---------------------------

0017608241602423
D/S Embankment
looking E

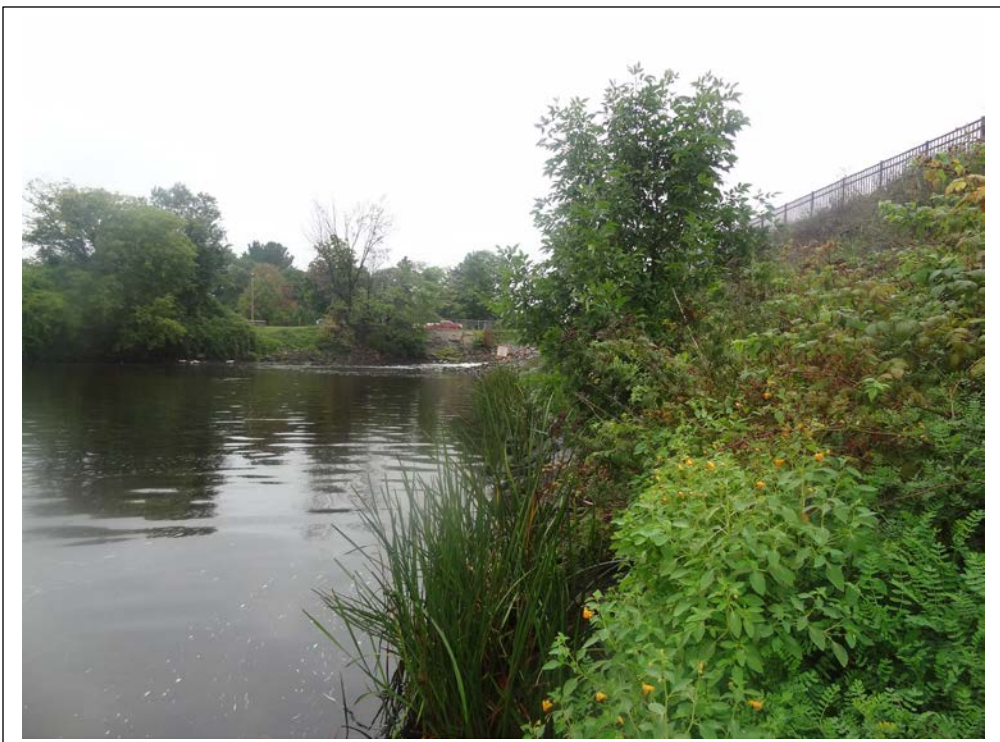
Photo No. 20	Date: 8/24/2016
------------------------	---------------------------

0017608241602426
D/S Embankment
looking W

wood shrub growth to
be cut

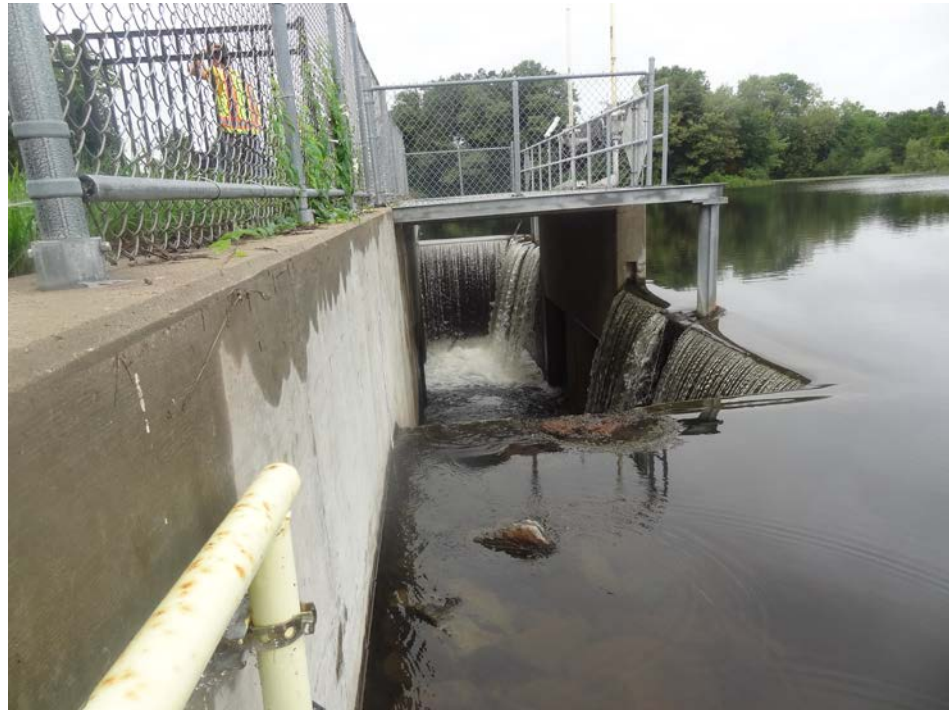
Photo No.
21

0017608241602435
Fixed Crest Spillway
looking W

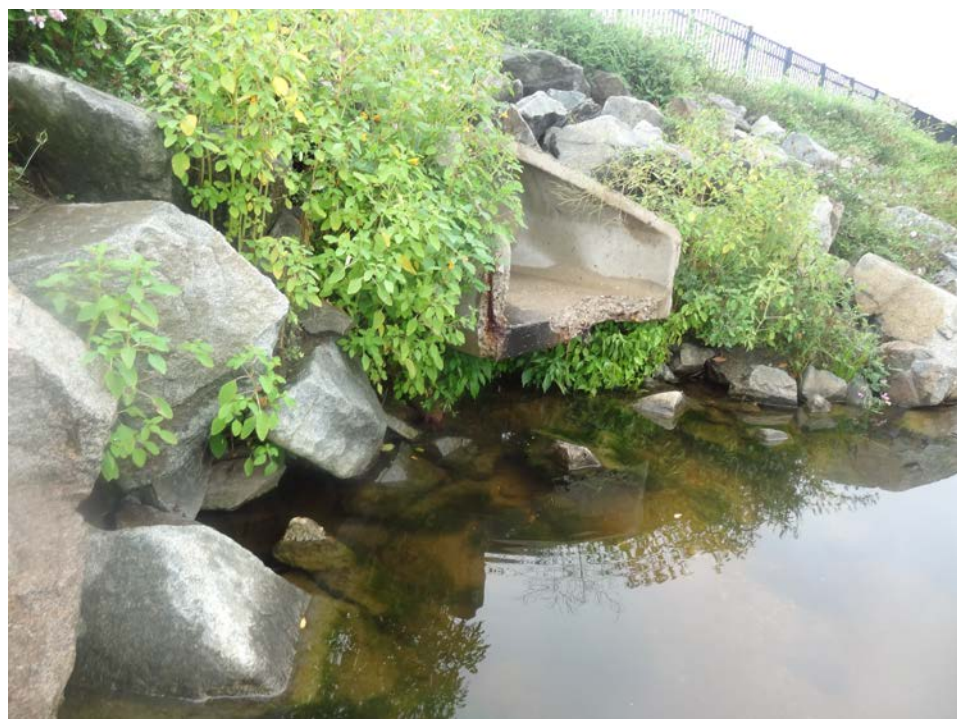
Photo No.
22

0017608241602437
Storm Outfall U/S
Embankment

Requires additional
stone

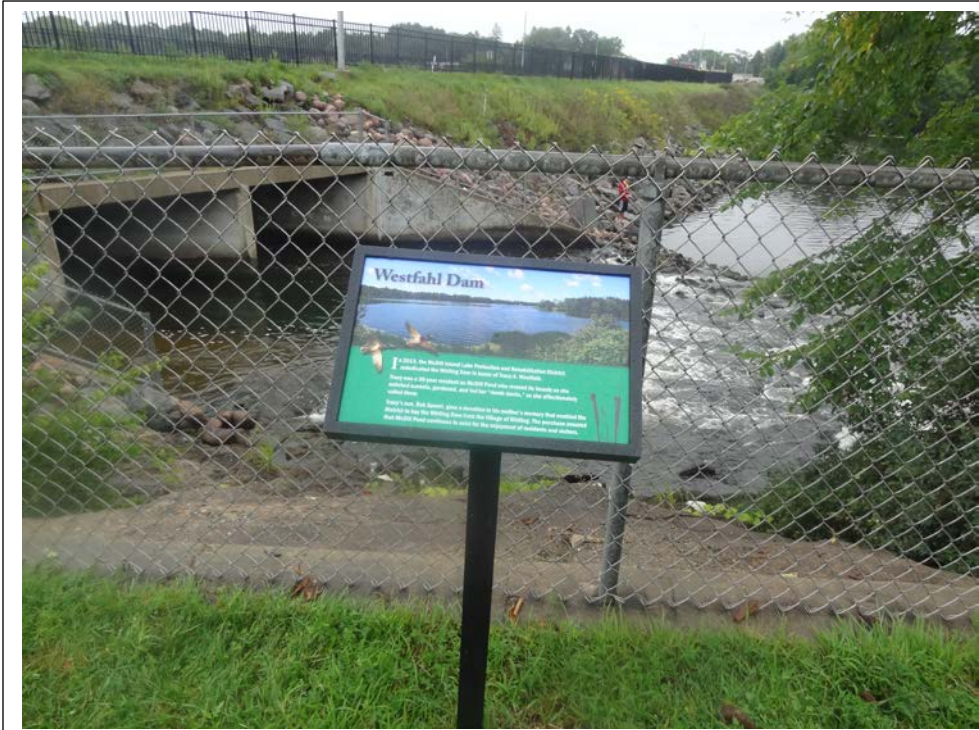
Photo No. 23	Date: 8/24/2016
------------------------	---------------------------

0017608241602442
Dam Identification Sign

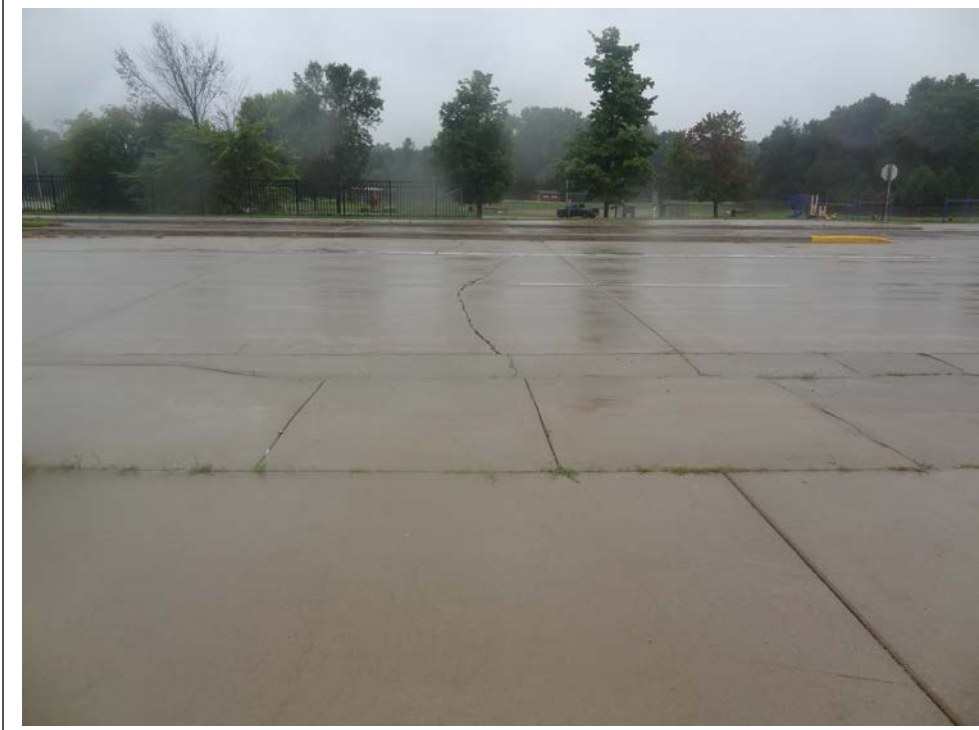
Photo No. 24	Date: 8/24/2016
------------------------	---------------------------

0017608241602456
Pavement Cracking on highway pavement over box culvert system

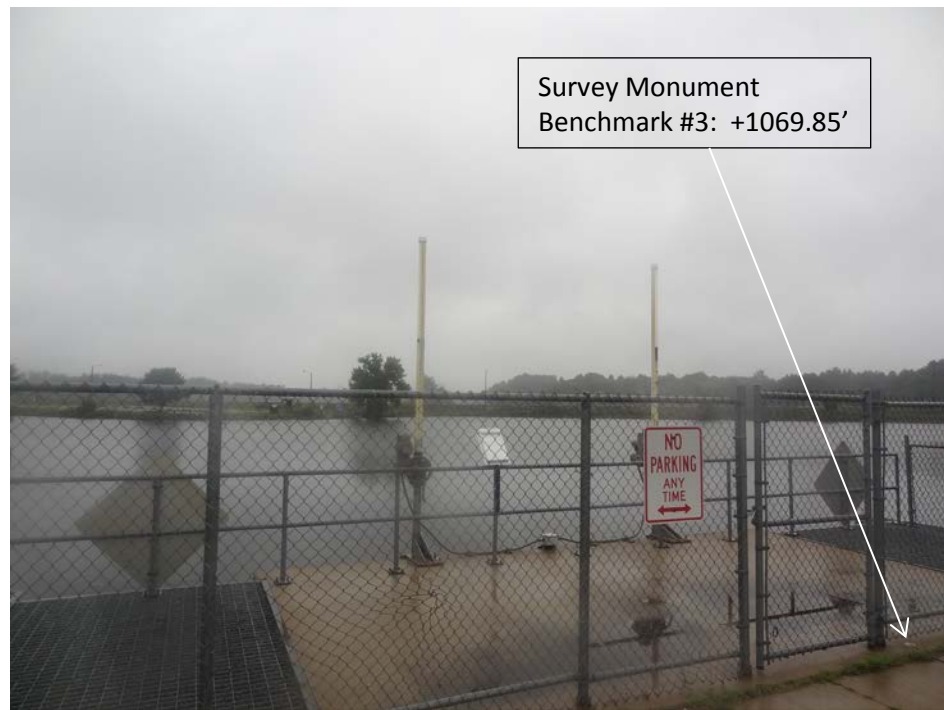
Photo No.
25

0017608241602458
Operators Deck and
Security Fencing
looking N

Benchmark #3
Monument (+1069.85')

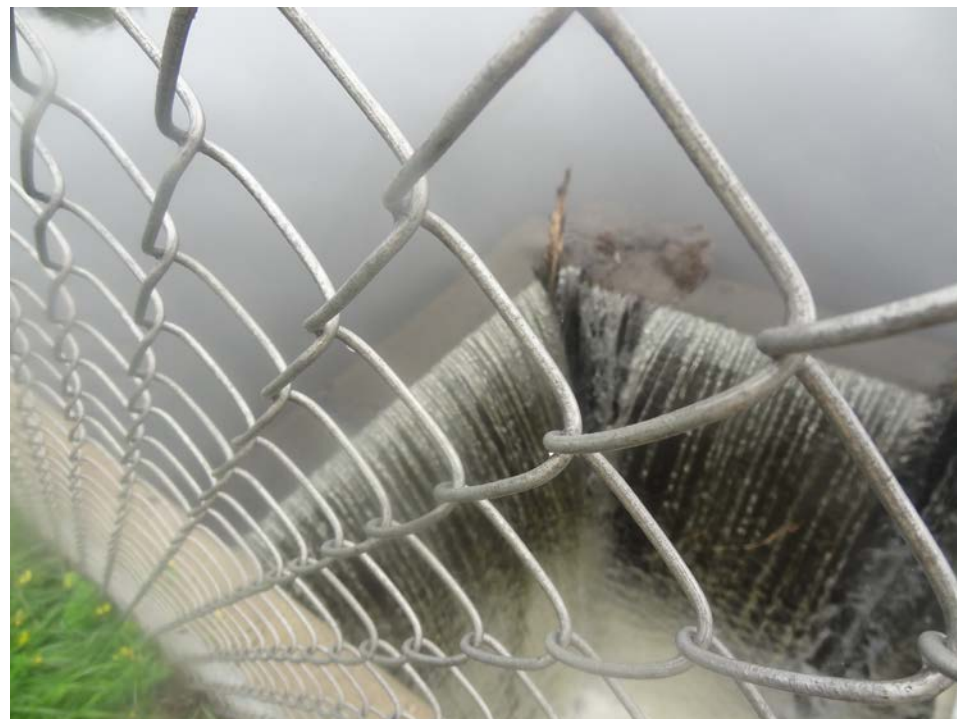
Photo No.
26

0017608241602459
Fixed Crest Spillway
West looking NW

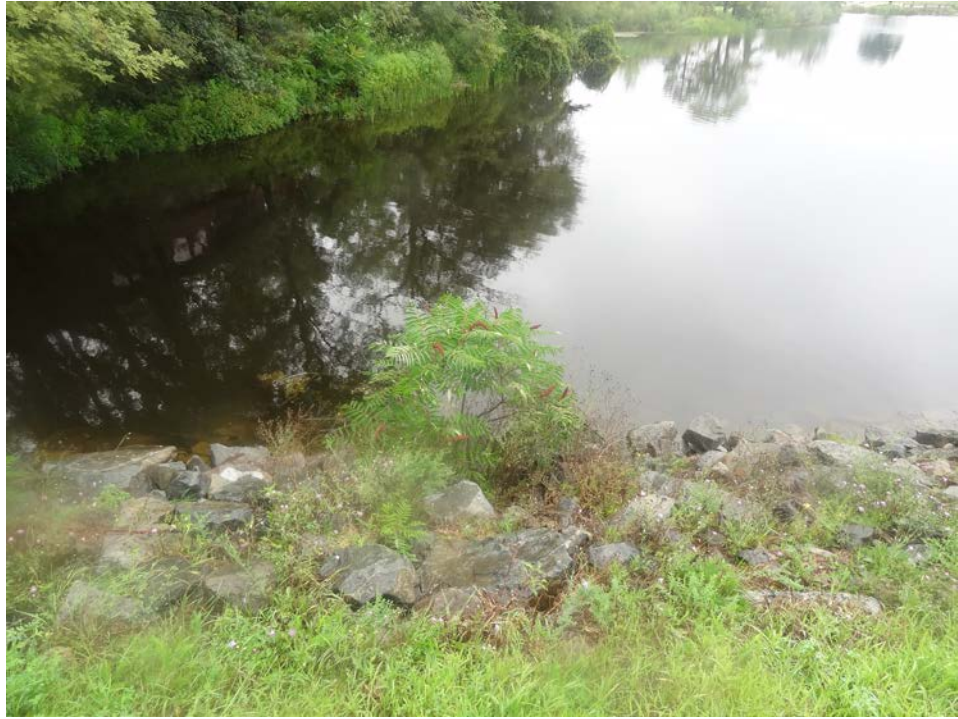
Photo No. 27	Date: 8/24/2016
------------------------	---------------------------

0017608241602462
Sumac shrub on D/S
Embankment

To be removed
